# Test report

**sub-structure waterproofing system**

**Plastic pipe penetration through**

**Zemseal<sup>®</sup> sub-structure waterproofing membrane**

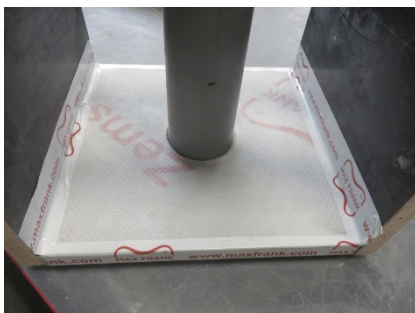
- a) A  $\varnothing$  80 mm opening is cut in the centre of a Zemseal® section and a plastic pipe with an outer  $\varnothing$  of 75 mm is inserted.

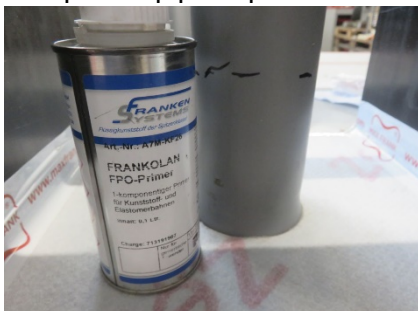
- b) The plastic pipe is pre-treated on the outside circumferential with "Frankolan FPO-Primer".

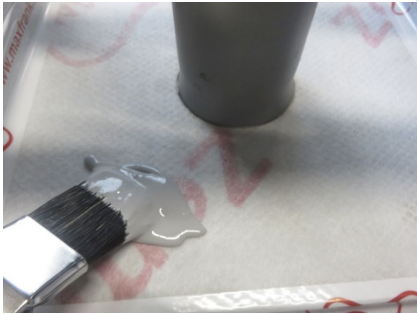
- c) Sealing of the transition between the Zemseal® sub-structure waterproofing membrane and the plastic pipe with approx. 10 cm overlapping applied "Frankosil 1K Plus" in 2 work steps including fabric insertion.  
Total thickness of the applied layer: 3 – 3,5 mm

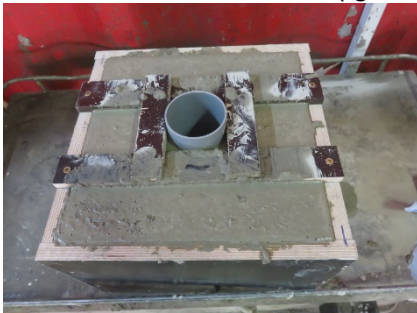
- d) After the liquid plastic has cured (24 hours), the formwork of the test specimen is closed and filled with a concrete ( grade C30/37).

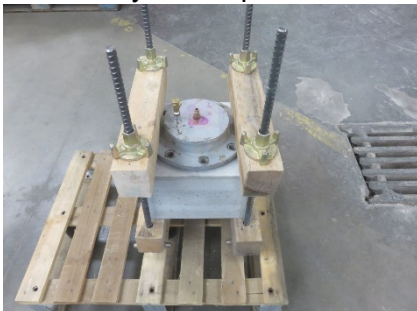
- e) After 5 days, the specimen shall be stripped and a test bell is installed.

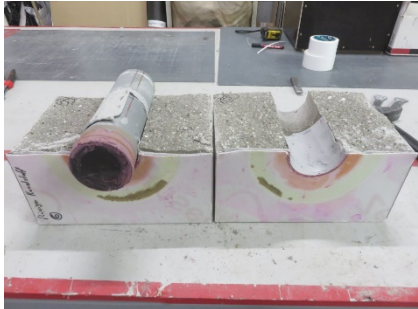
The result of the pressure test show no penetration of moisture along the penetrating plastic pipe.
